# Manhole Inspection Summary

Manhole # S23MM\_005MH

Insp Date: **8/27/07 12:30 PM**

**Location** Address: **2518 DRUID HILL AVE**

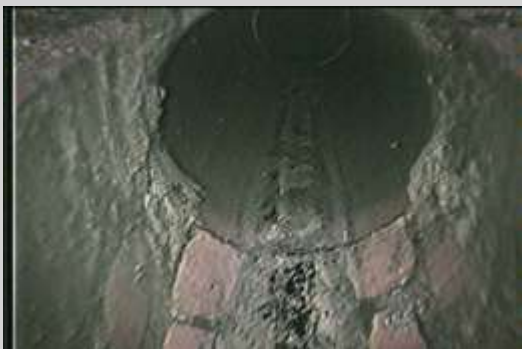
### 8 in. Circular Gravity Sewer Pipe In @ 6 O'Clock

Invert Depth: **9.80** (ft.) Flow Characteristics: **Slow**

Infiltration: **None** Pipe Seal Cond: **Unknown**

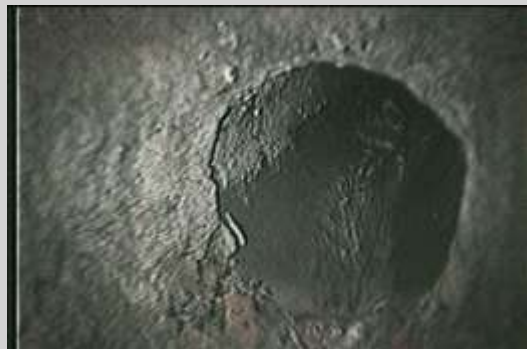
Pipe In @ 9 O'Clock

Infiltration: **None**
